Christchurch Earthquake Hazard Analysis and Risk Mitigation

Summary:

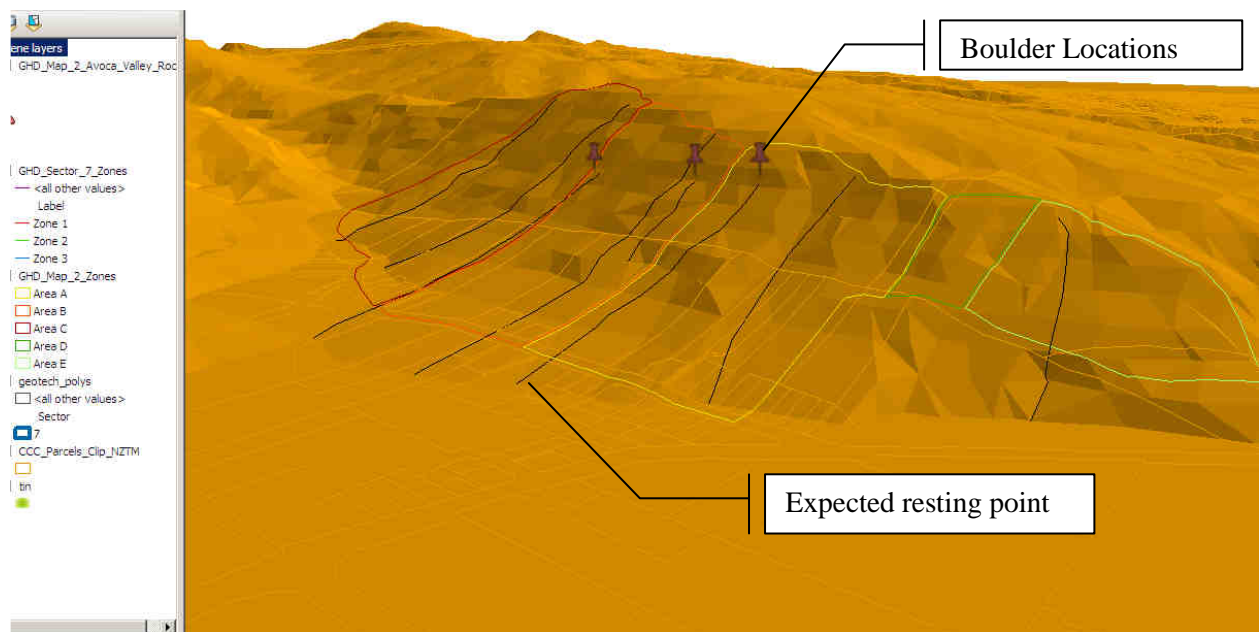
With data supplied that provided a hillside contour, it was possible to use the Create Steepest Path tool in ArcScene to find the likely path a boulder would take if it rolled down the Port Hills. The features were draped over a tin created using the contour data. The output produced below was able to be run for all scenarios of identified rockfall hazards.

Figure 7. 3D Model of Port Hills with Steepest Path of each Boulder

With an indicative resting point identified, the 60° Cone of Risk could be placed in the middle of the resting point. This enabled the use of the Intersection tool to identify all address parcels that the Cones of Risk breached. These addresses were then reported as higher risk areas.
